MEWP Boom Failure

Alert | HiPo | Update | Zero Tolerance

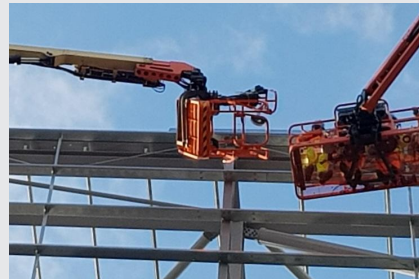
A JLG1850 boom type MEWP was working at high level (approximately 40m above the ground) when it failed to respond to the operating controls and then tipped to one side. The two operatives in the basket fell (within the basket) but were unharmed. A high level rescue was performed by an adjacent MEWP and the operatives were recovered to the ground safely and without further incident.

A thorough investigation is still on-going, with the components suspected of contributing to the incident being sent away for forensic examination. Whilst it is still too early to confirm the cause of the failure, one of the contributing factors is now known to be a check valve that was found to be stuck in the open position.

- Making sure that all operatives using boom type MEWPs are correctly wearing their harnesses and clipped on. The fact that both individuals were correctly clipped on in this incident may have saved their lives.

- Check that all MEWPs on arrival have been correctly serviced in line with manufacturers requirements and this specifically includes changing hydraulic fluids at correctly specified timescales

- Check that all MEWPs clearly show when the next service is due both in terms of a date and hours worked (whichever is the sooner). It is worth noting that some hire companies will only service their units when they are off-hired and returned to the depots. However, if you are using a unit for long period of time or for multiple shifts, then the time before the next service can be dramatically reduced

- Remind operatives that if they notice any abnormal movement when operating MEWPs, they should immediately return to ground level and report it.
